# ROAD SAFETY REVIEW OF JUNCTION FOR PROPOSED RESIDENTIAL DEVELOPMENT, EDINBURGH RD, PEEBLES.

Report Ref 79319

## Road Safety Review – Edinburgh Road, Peebles.

# Venlaw, Peebles - Design & Access Statement

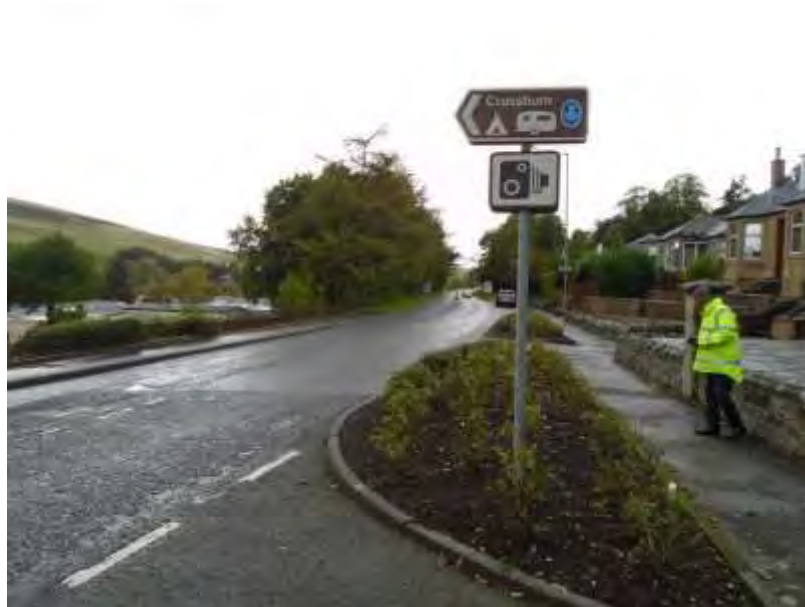
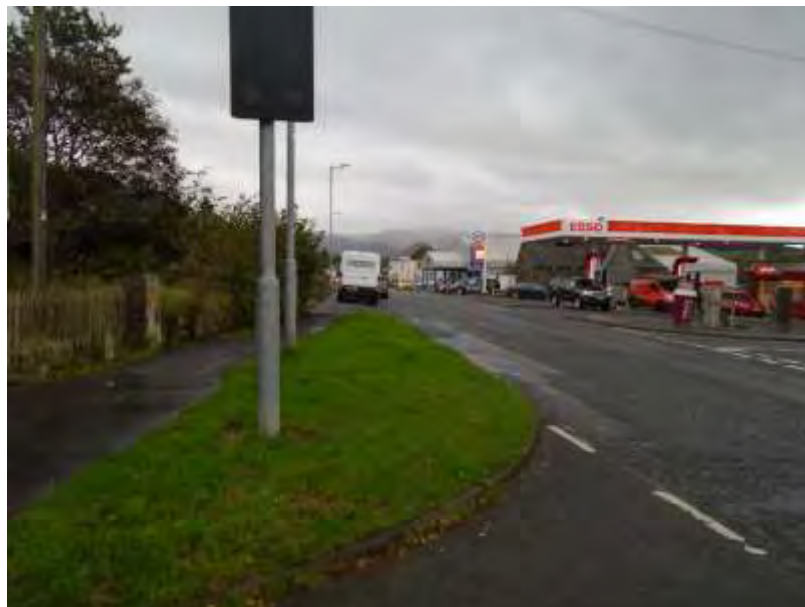
- 5.1. Sightlines, taken at 2.4m back from the proposed site access road are good due to the curved horizontal profile of the A703.

- 5.1. Sightlines, taken at 2.4m back from the proposed site access road are good due to the curved horizontal profile of the A703.

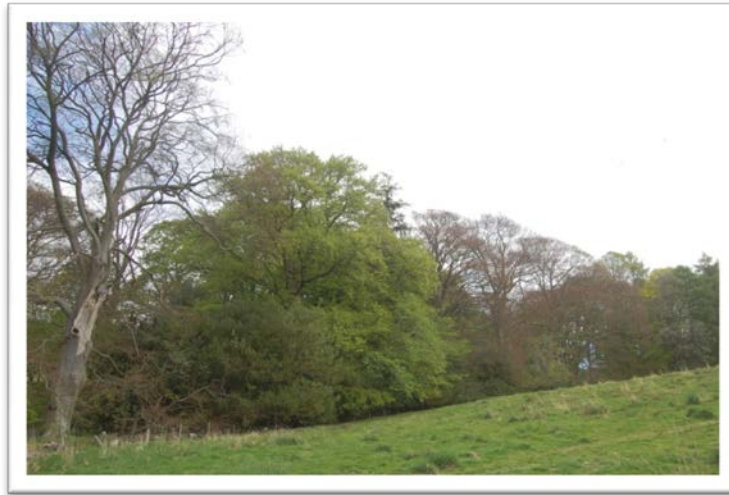
**Photo 1.** Trees on north boundary, viewed from site (looking east).

A total of 53 trees collectively form a wooded belt running west to east which follows the gully formed by the burn (see photos 1 to 4). These comprise a broad range of species and age class, and form a single, contiguous canopy.

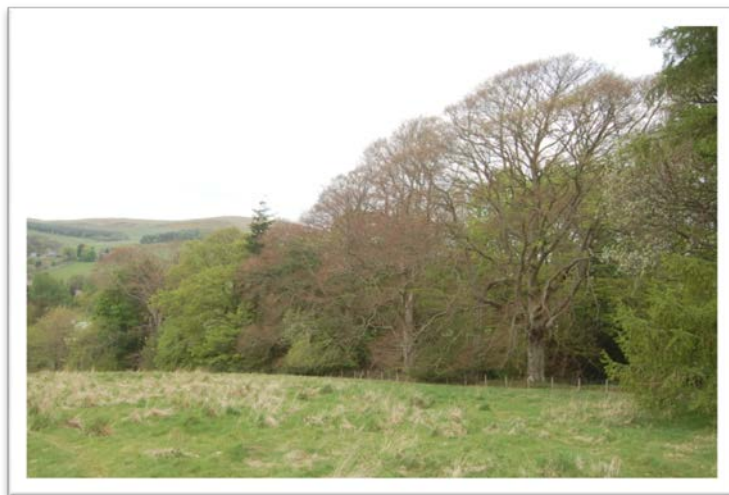
**Photo 2.** Trees on north boundary, viewed from site (looking west).

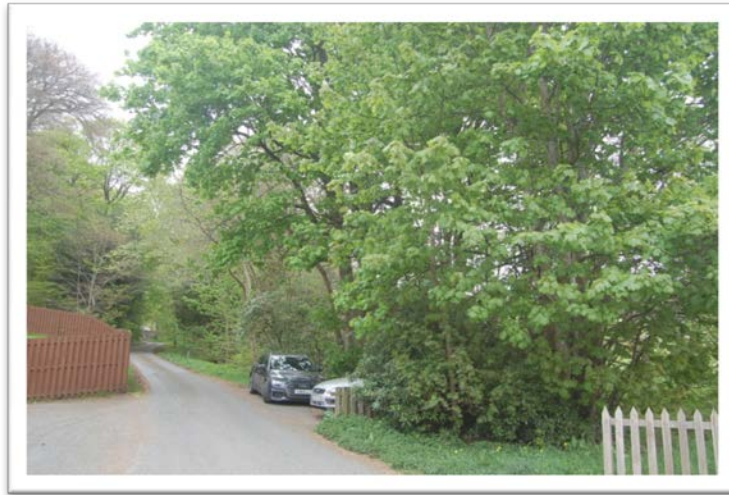
**Photo 3.** Trees on north boundary, viewed from road to Venlaw (looking east).

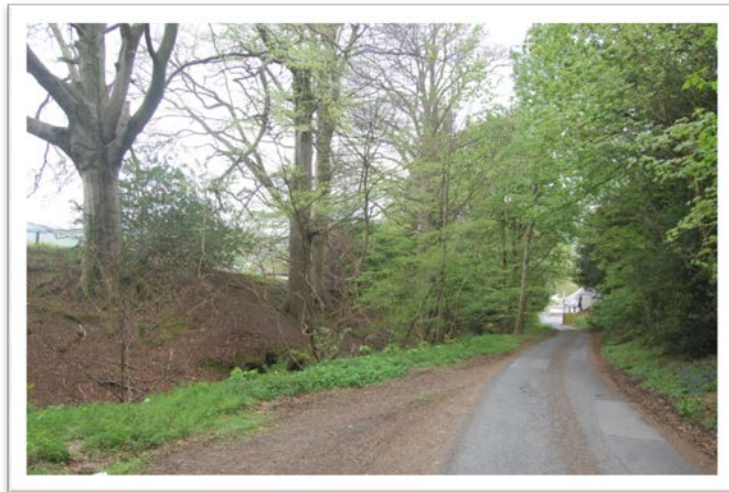
**Photo 4.** Trees on north boundary, viewed from road to Venlaw (looking west).

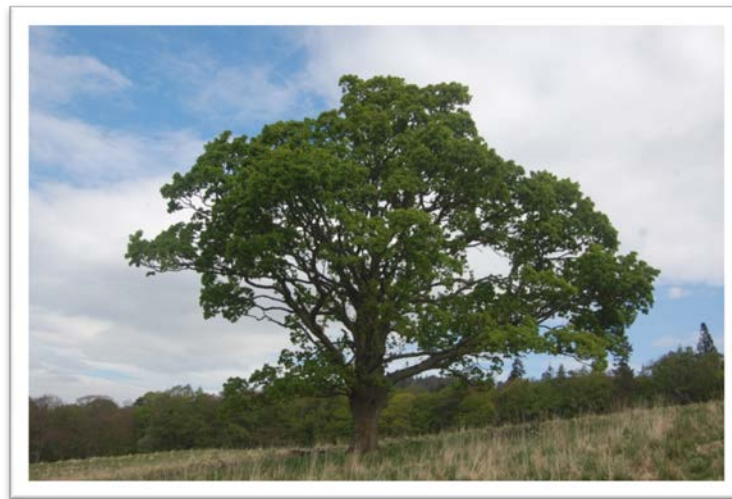
**Photo 5.** Tree 611.

These are a pair of large, mature sycamore which stand as prominent specimens within the parkland (see photos 5 and 6). They are of large size and stature, with full and well-balanced open-grown crowns. They are in the region of 250 years in age and form part of the early plantings associated with Castle Venlaw, which stands to the east. They are generally in satisfactory condition and have a reasonable future life expectancy.

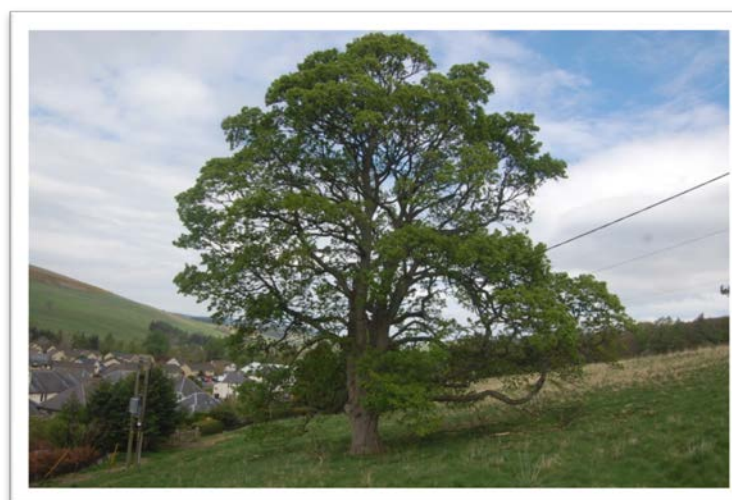
**Photo 6.** Tree 612.

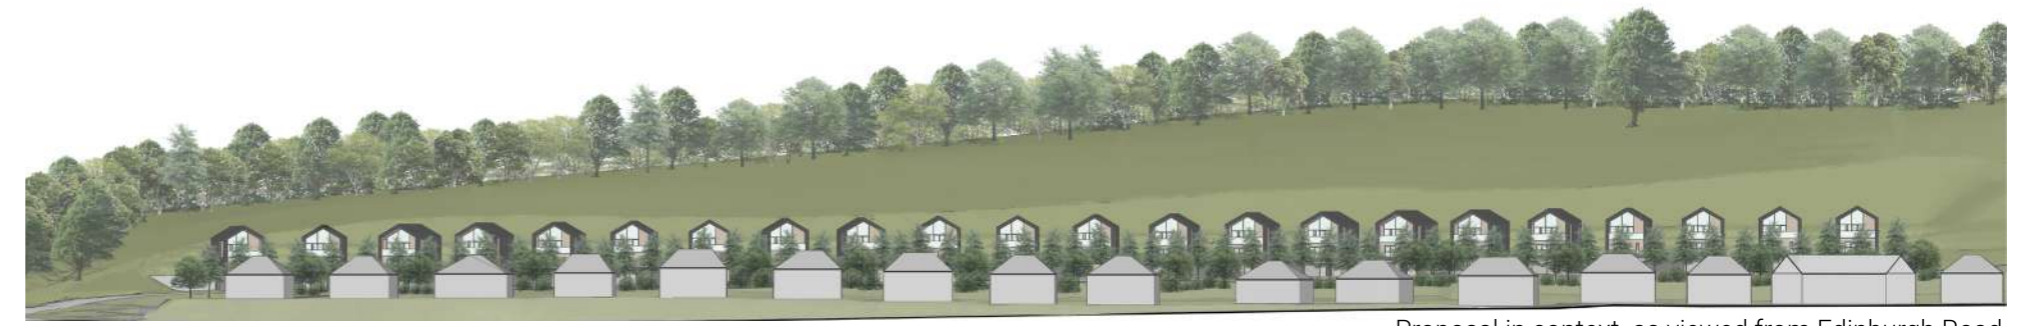
Proposal in context as viewed from Edinburgh Road

The site is visually prominent from a number of locations due to the steep incline of the slope and the open landscape character of the valley. Again, by locating the proposals to the lower portion of the site and following the linear character of the existing dwelling to the A703, any visual impact is minimised.

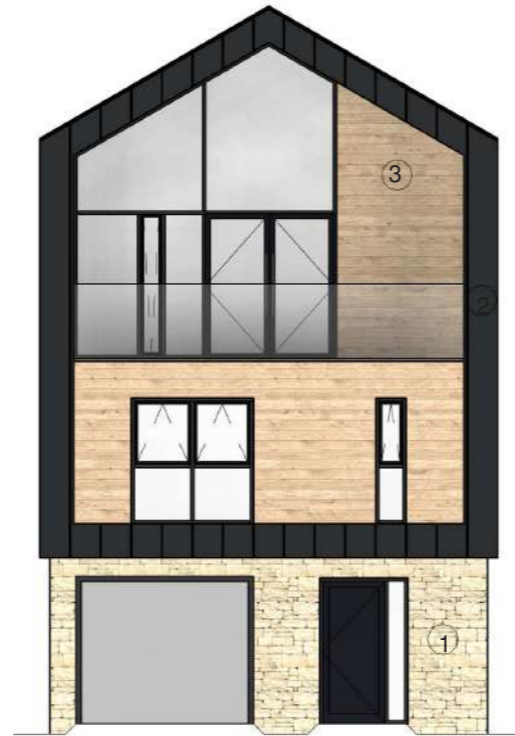
1. Stone Cladding
2. Flat lock Zinc Cladding Panels
3. Horizontal Timber Cladding Panels

West Elevation

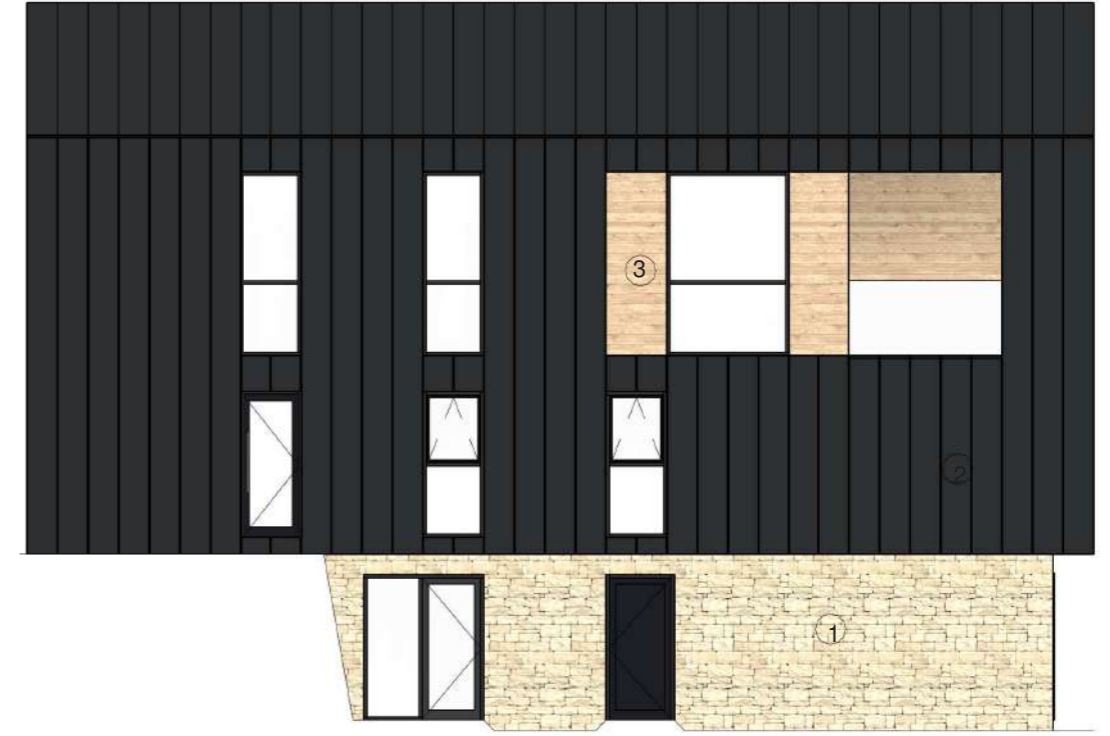
North Elevation

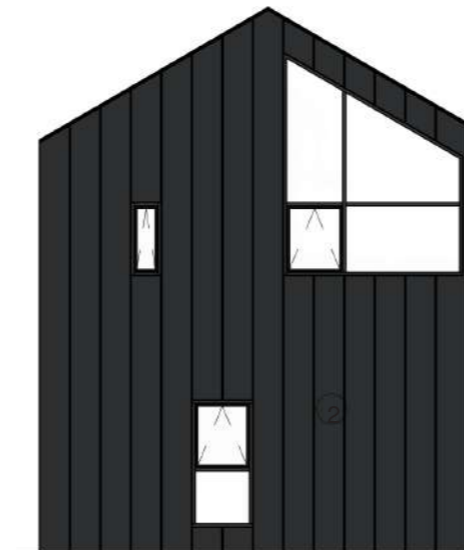
East Elevation
