B6399 update – Thursday 5 March 2020

During the ongoing works on the B6399 further significant damage has been identified near Whitropefoot.

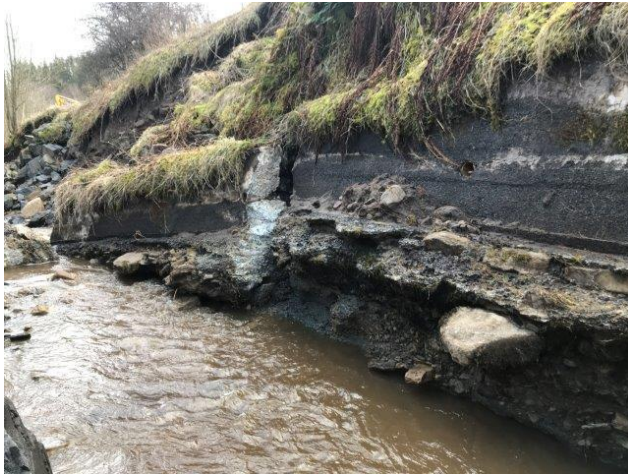
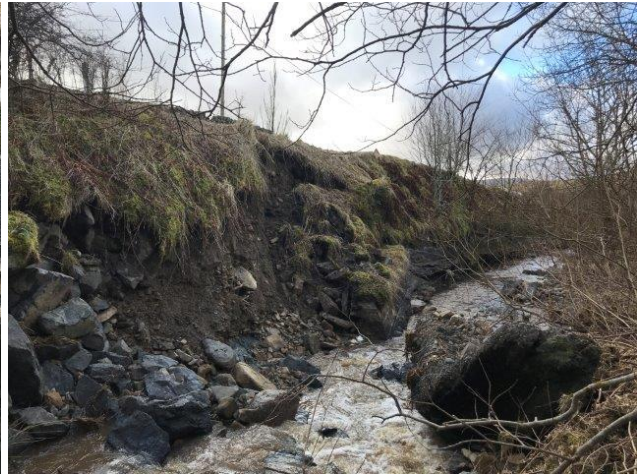
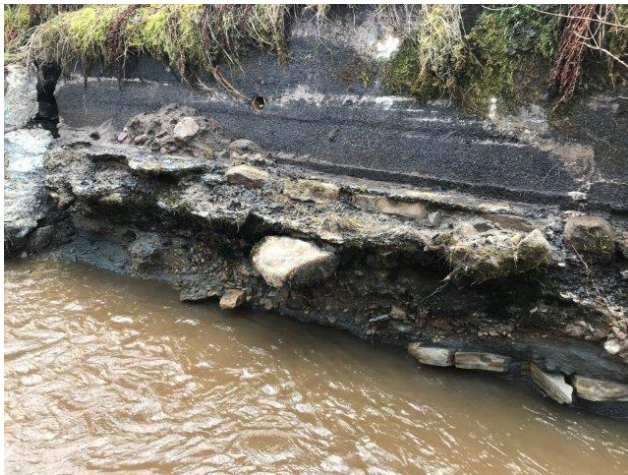
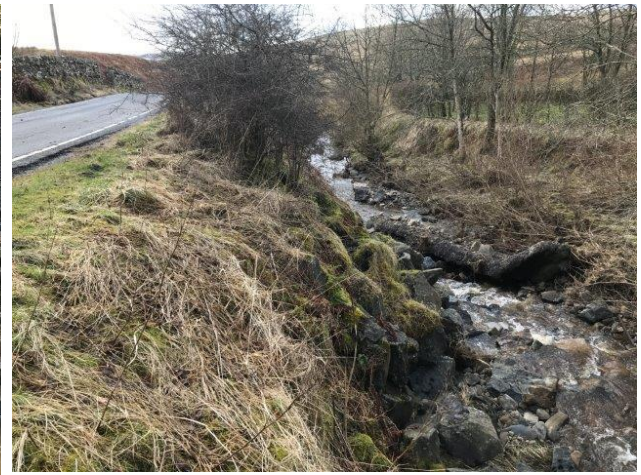
It appears that the bed of the river here has dropped, exposing a previously unidentified concrete support layer which holds up a large, steep embankment and the road above. This layer of concrete has been undermined by erosion and has split in places, resulting in the embankment slipping and making it unsafe to travel on the adjacent road.

The following images will assist in your understanding of the damage that has occurred.

Unfortunately the complexity of the site and the extent of the repair required will necessitate a further extension to the road closure on the B6399.

It is currently estimated that it will now take a further three weeks until 6 April to complete this repair in addition to the other areas of damage already identified.
